How to change serpentine belt on SKODA Octavia I Combi (1U5) – replacement guide

REPLACEMENT: SERPENTINE BELT – SKODA OCTAVIA I COMBI (1U5). TOOLS YOU'LL NEED:

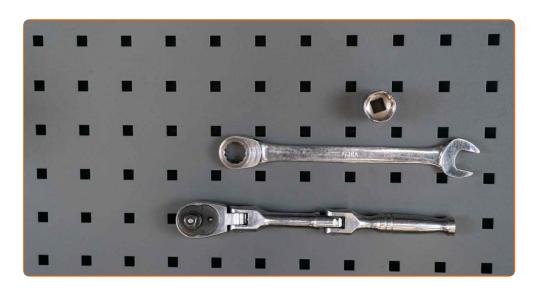
- Combination spanner #16
- Drive socket # 19

- Ratchet wrench
- Fender cover
