How to change
distributor cap on **SEAT**
Cordoba Vario (6K5) –
replacement guide

REPLACEMENT: DISTRIBUTOR CAP – SEAT CORDOBA VARIO (6K5). TOOLS YOU NEED:

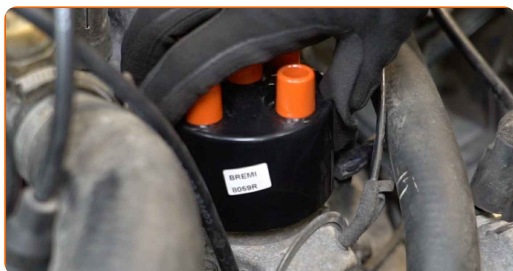
7

Install a new distributor cap.

- Replacement: distributor cap – SEAT Cordoba Vario (6K5). Do not use excessive force during installation. This may damage the part.
